# Polybutylene Piping

## What Is Polybutylene?

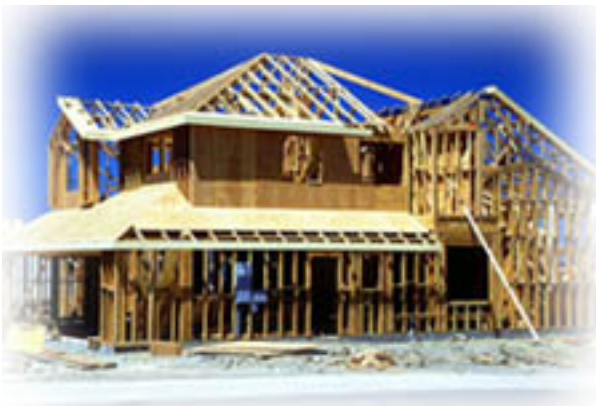
Exterior - Polybutylene underground water mains are usually blue, but may be gray or black (do not confuse black poly with polyethelene pipe). It is usually 1/2" or 1" in diameter, and it may be found entering your home

through the basement wall or floor, concrete slab or coming up through your crawlspace; frequently it enters the home near the water heater. Your main shutoff valve is attached to the end of the water main. Also, you should check at the water meter that is located at the street, near the city water main. It is wise to check at both ends of the pipe because we have found cases where copper pipe enters the home, and poly pipe is at the water meter. Obviously, both pipes were used and connected somewhere underground.

Interior - Polybutylene used inside your home can be found near the water heater, running across the ceiling in unfinished basements, and coming out of the walls to feed sinks and toilets. Warning: In some regions of the country plumbers used copper "stub outs" where the pipe exits a wall to feed a fixture, so seeing copper here does not mean that you do not have poly.

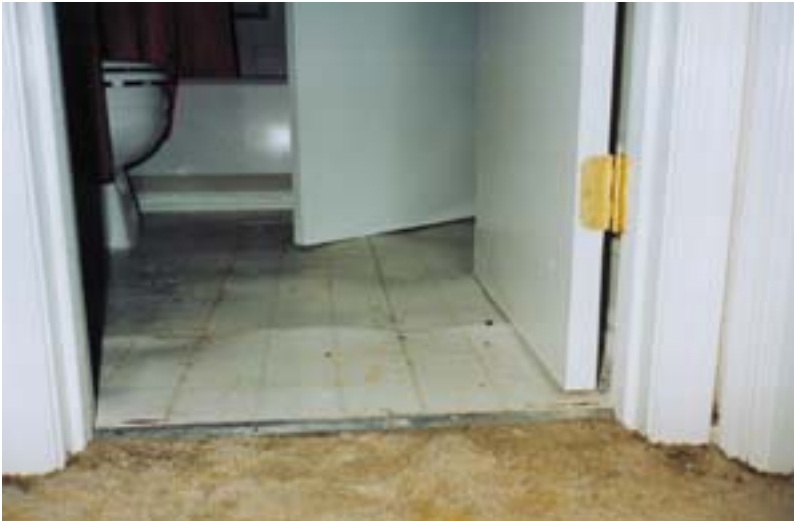
While scientific evidence is scarce, it is believed that oxidants in the public water supplies, such as chlorine, react with the polybutylene piping and acetal fittings causing them to scale and flake and become brittle. Micro-fractures result, and the basic structural integrity of the system is reduced. Thus, the system

becomes weak and may fail without warning causing damage to the building structure and personal property. It is believed that other factors may also contribute to the failure of polybutylene systems, such as improper installation, but it is virtually impossible to detect installation problems throughout an entire system.
